**CONSENT ORDER
ISSUED UNDER THE
WATER POLLUTION CONTROL ACT
WEST VIRGINIA CODE, CHAPTER 22, ARTICLE 11**

TO: MarkWest Liberty Midstream & Resources, L.L.C. DATE: March 28, 2019
Gregory Bezdek, SVP, NE Region
4600 J Barry Ct. Ste 500
Canonsburg, PA 15317 ORDER NO.: 8945

MARKWEST LIBERTY MIDSTREAM & RESOURCES, L.L.C, WVR311004, Sherwood to Mobley
20" NGL, 8/22 & 8/23/2018

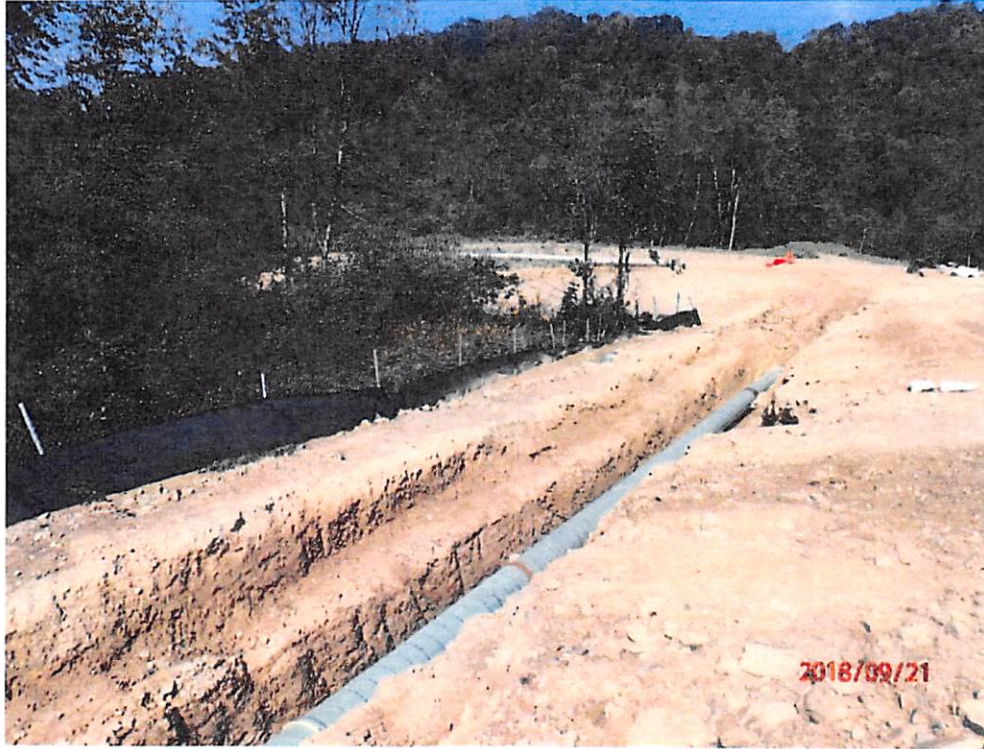
Super silt fence in need of maintenance near Route 20 bore site.

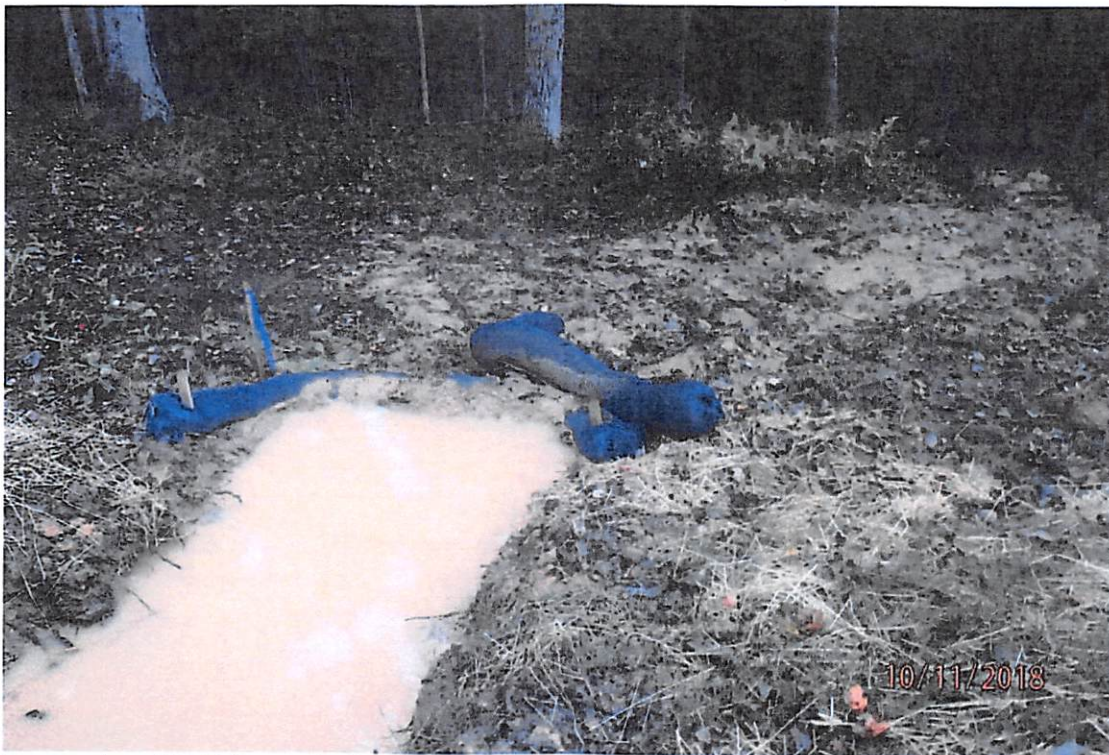
Water bar terminus BMP in need of maintenance and associated offsite sediment deposits in the Riggins Run watershed.

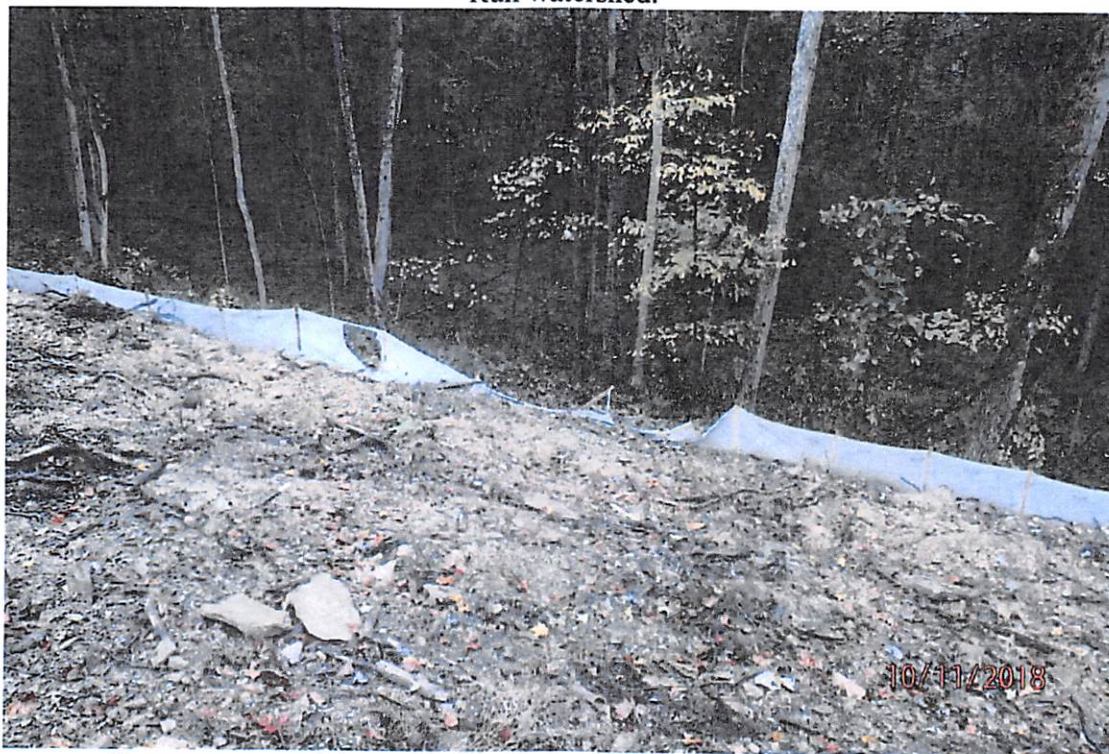
Perimeter control in need of maintenance in the Riggins Run watershed.

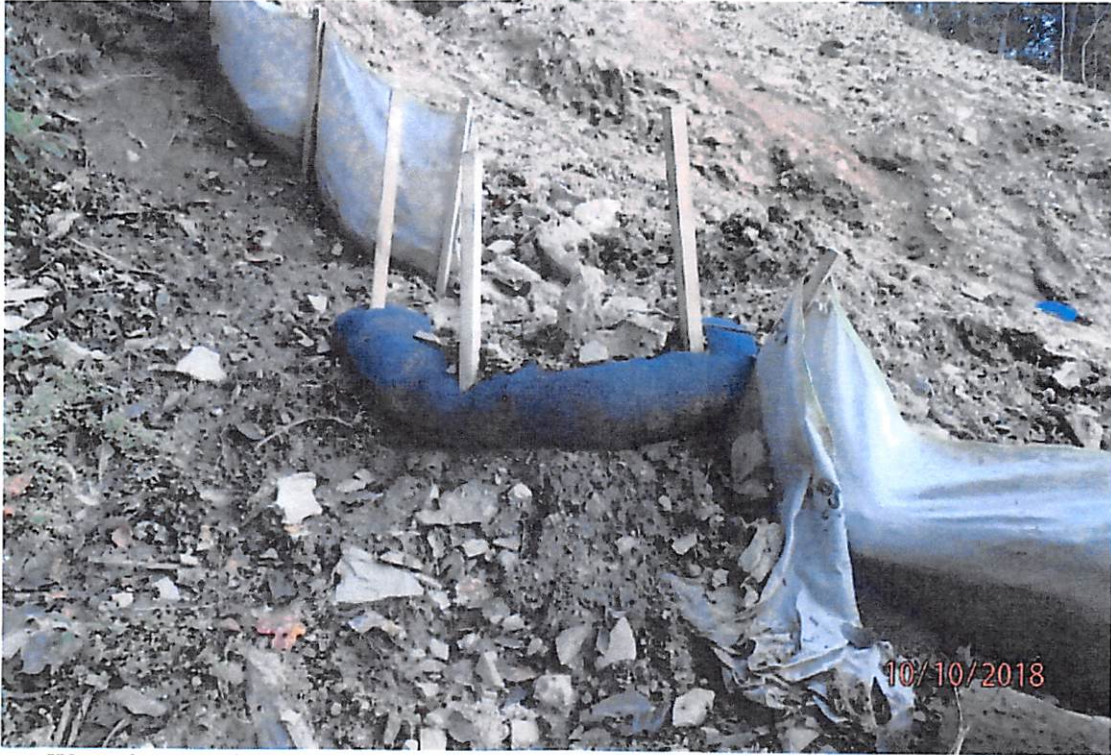
Water bar terminus BMP in need of maintenance in the Buckeye Creek watershed.

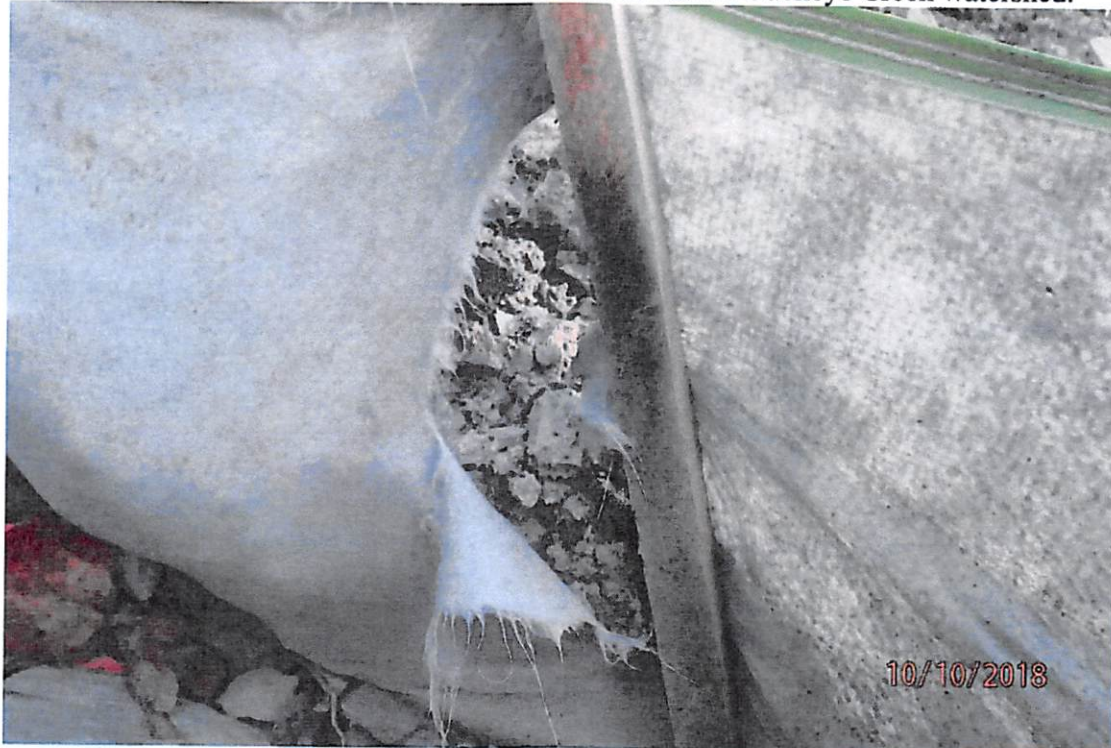
Perimeter control in need of maintenance in the Buckeye Creek watershed.

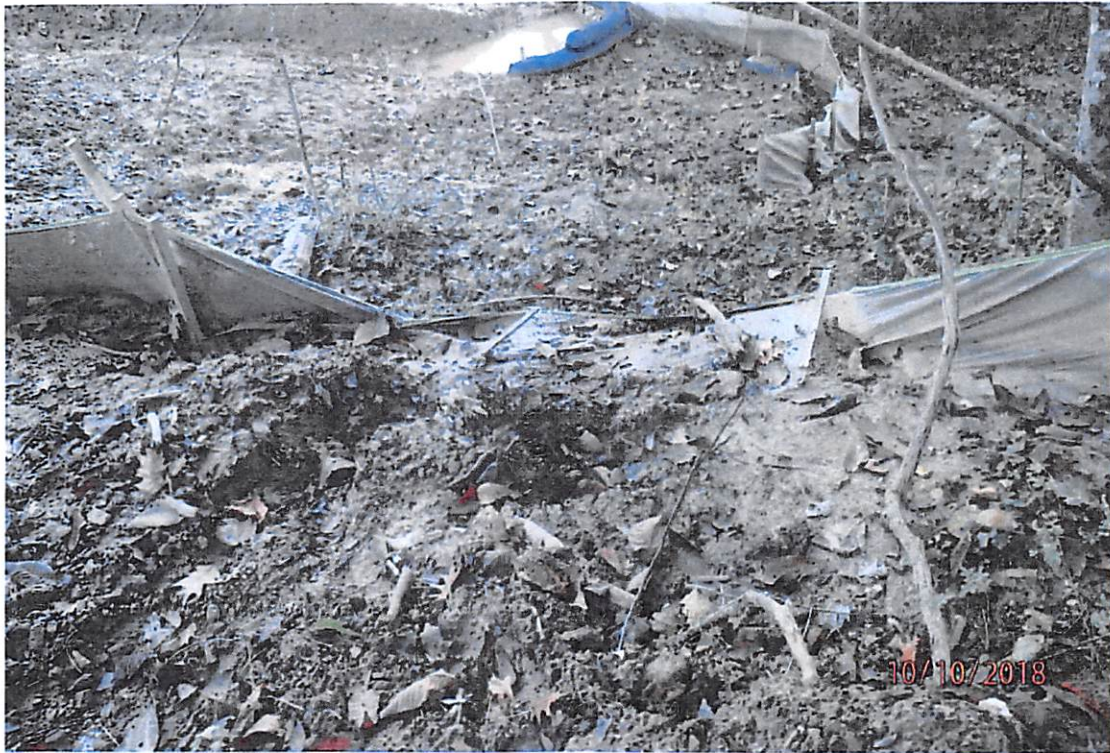
Perimeter control in need of maintenance in the Morgans Run watershed.

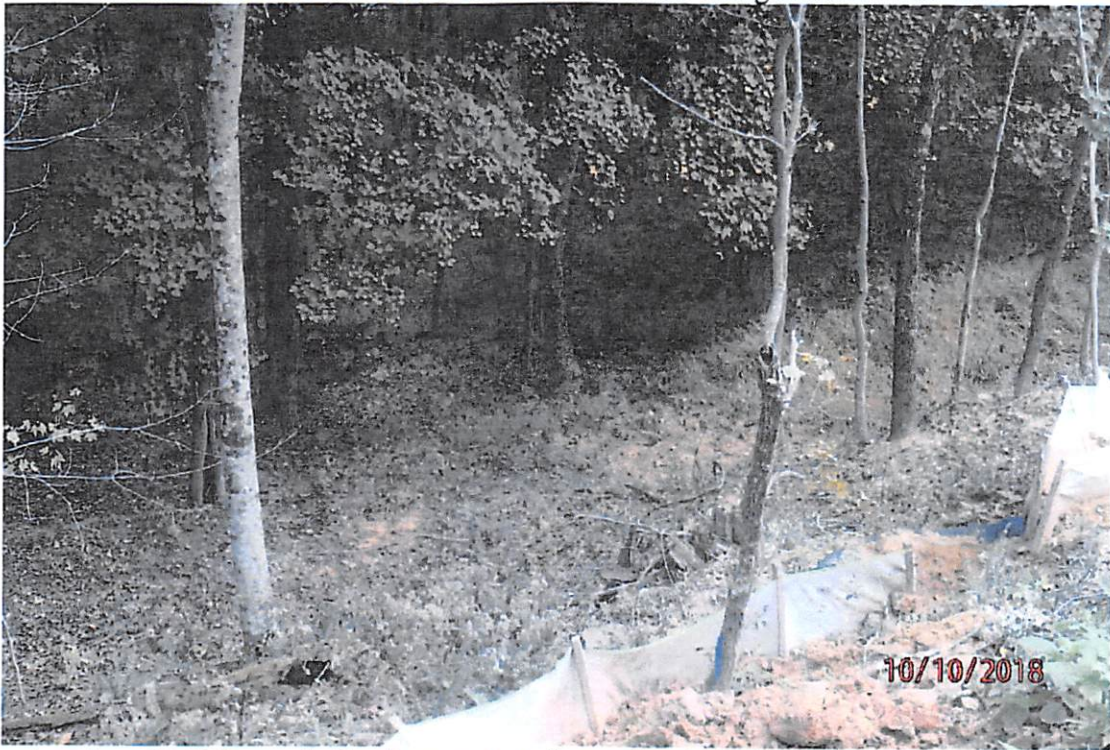
Water bar terminus BMP in need of maintenance and associated offsite sediment deposits in the Flint Run watershed.

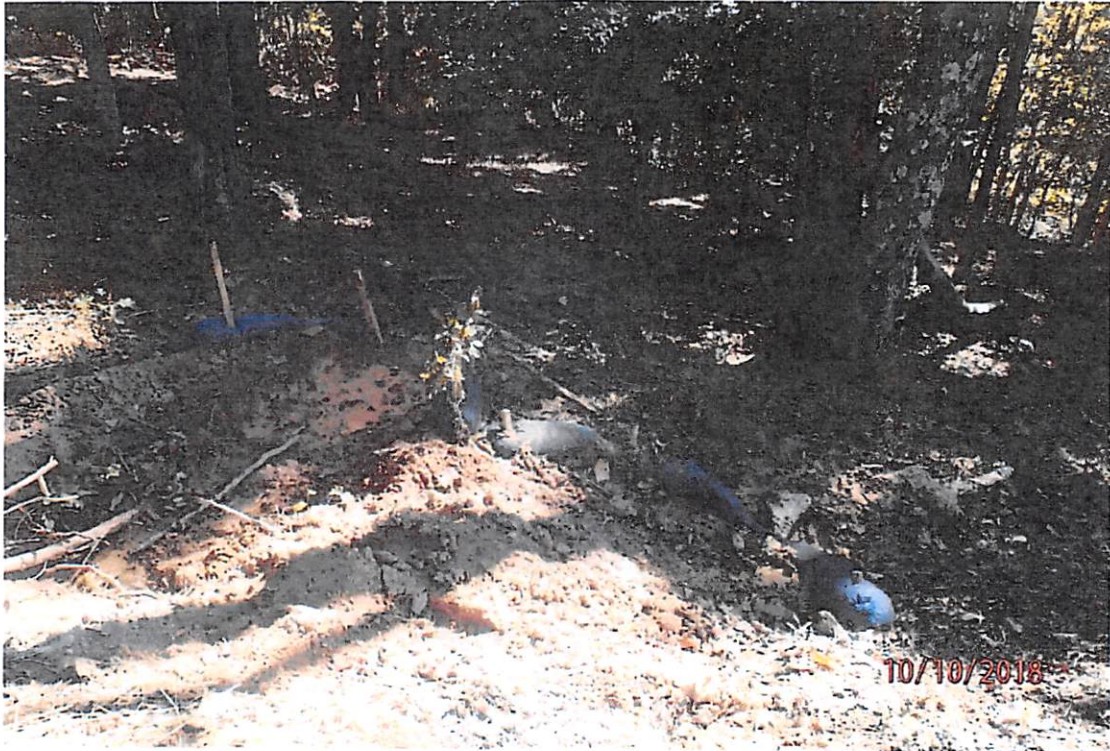
Water bar terminus BMP in need of maintenance adjacent to 153+00.

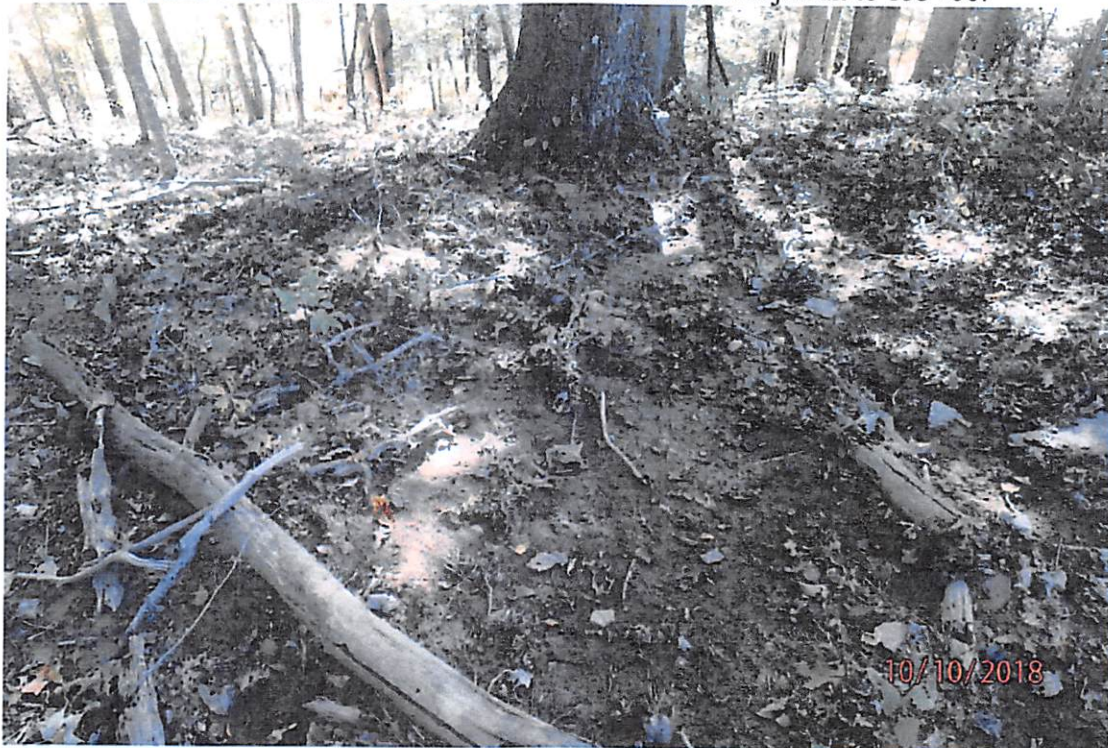
Offsite sediment deposits downslope of water bar terminus BMP adjacent to 153+00.

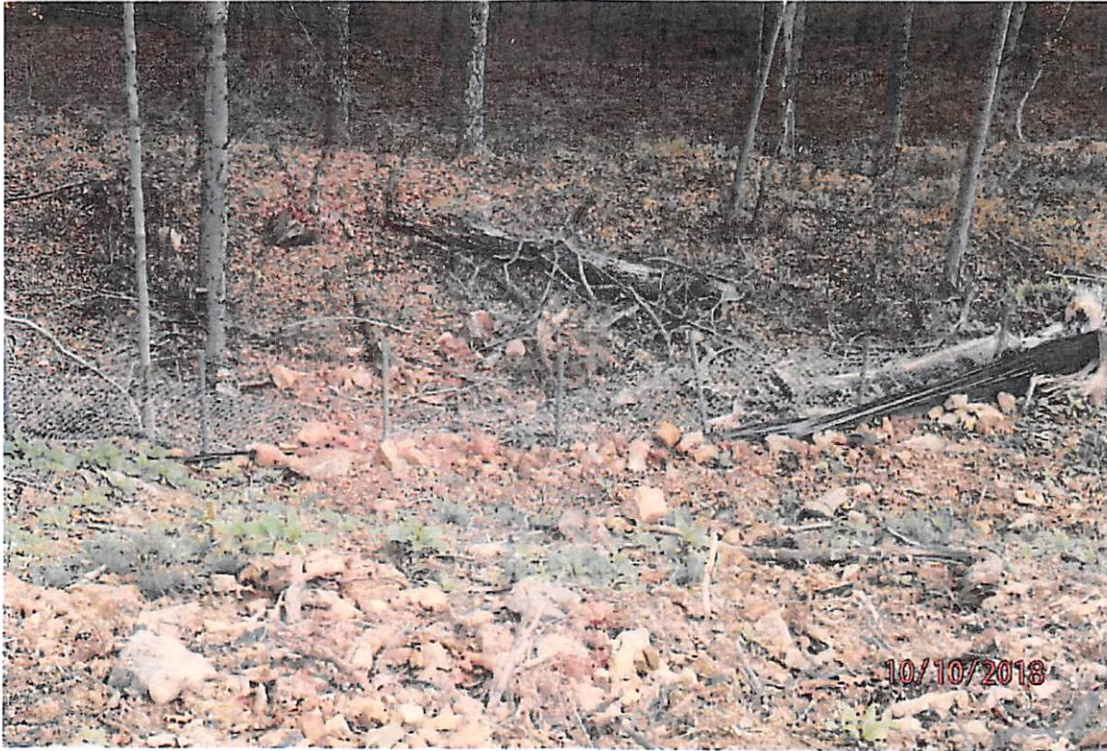
Perimeter control in need of maintenance in the Flint Run watershed.

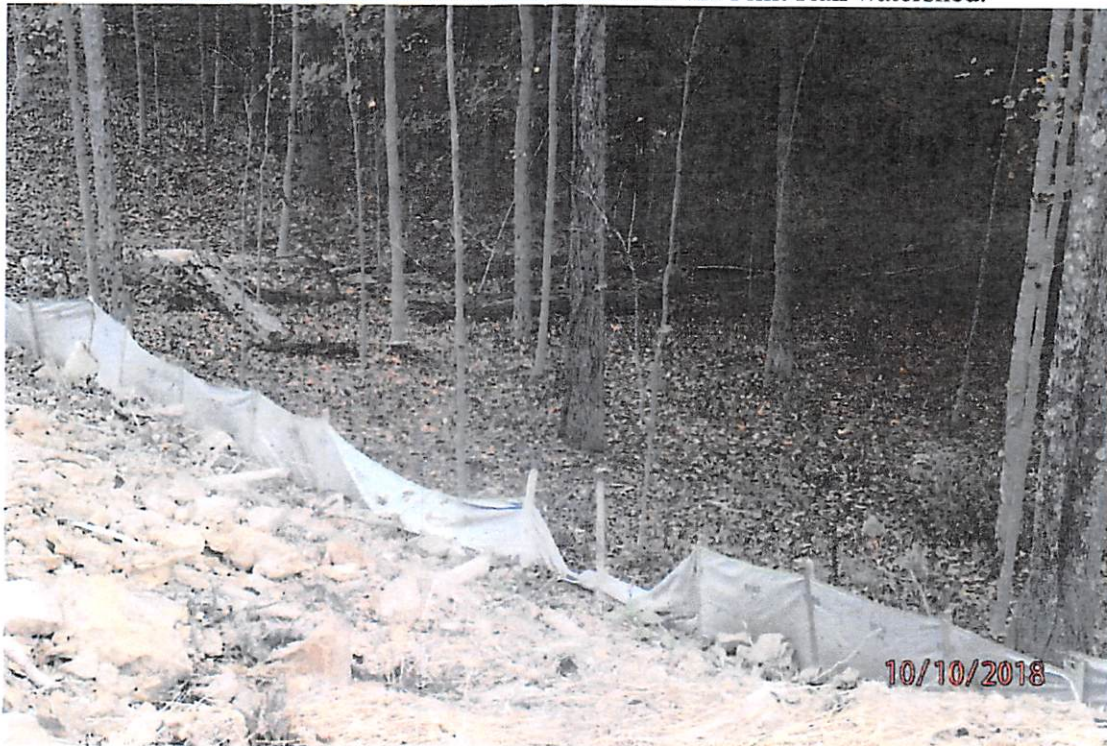
Perimeter control in need of maintenance in the Flint Run watershed.

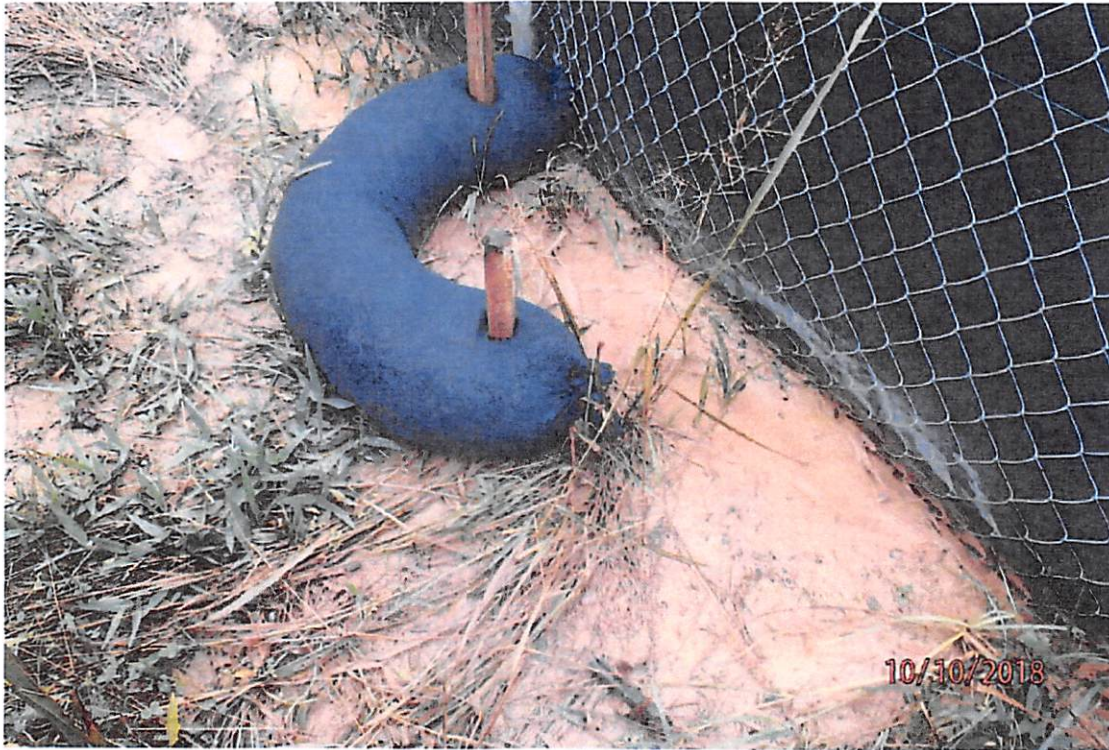
Perimeter control adjacent to 409+00 showing sediment laden water bypassing under the device.

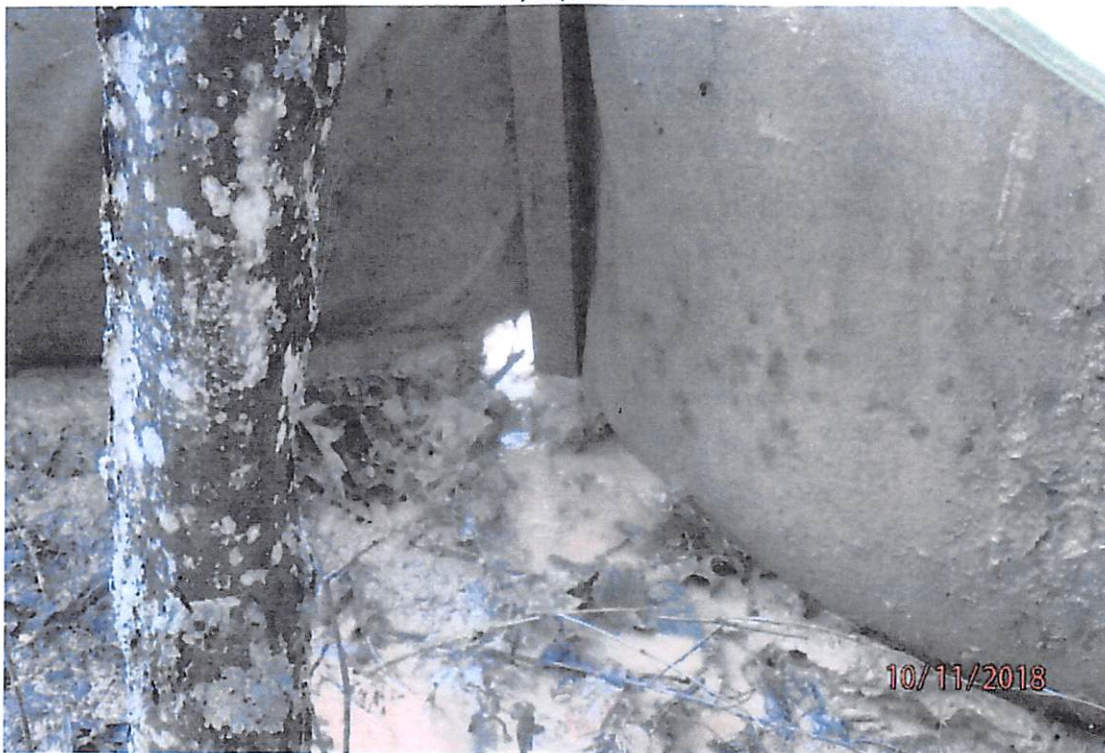
Sediment laden water passing through an unmaintained perimeter control adjacent to 872+00.

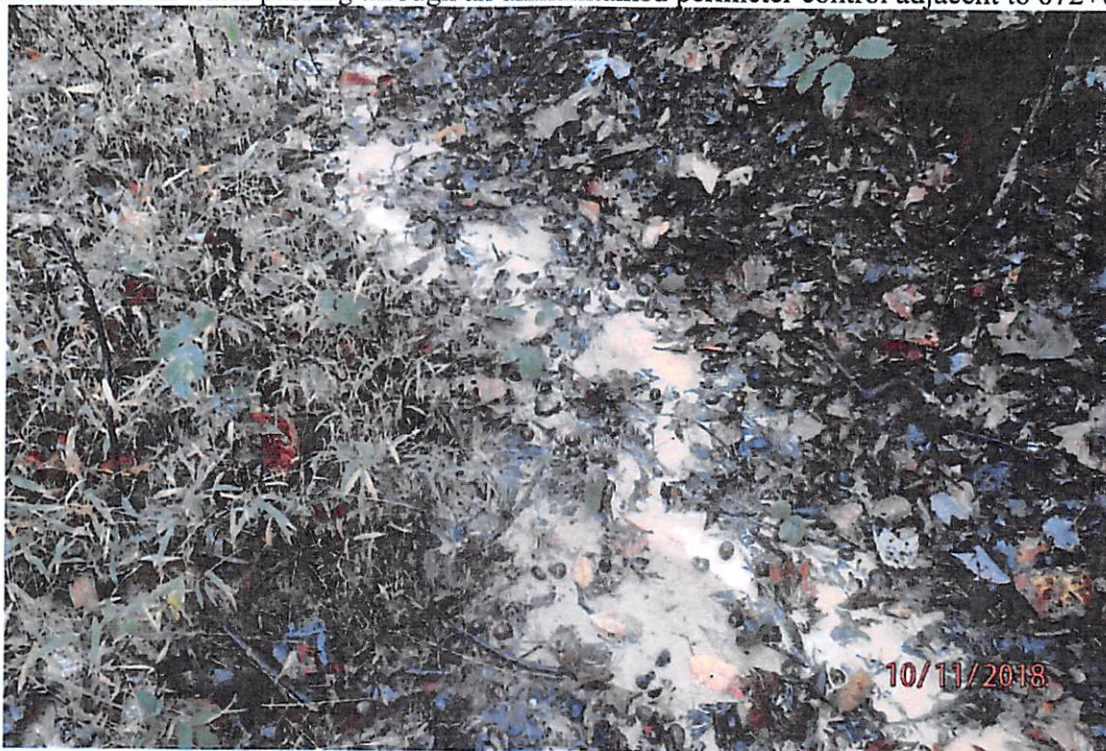
Offsite sediment deposits and sediment laden water that has bypassed the above pictured device adjacent to 872+00.

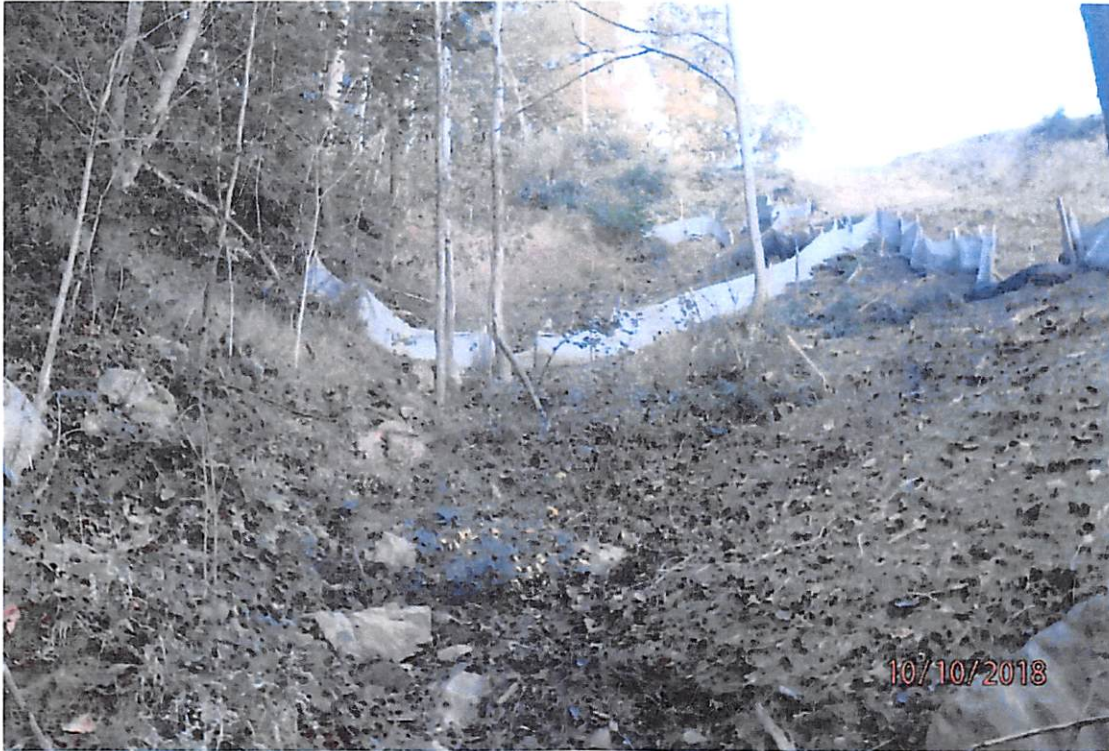
Overview of installed BMPs adjacent to UNT Buckeye Creek (UNT59).

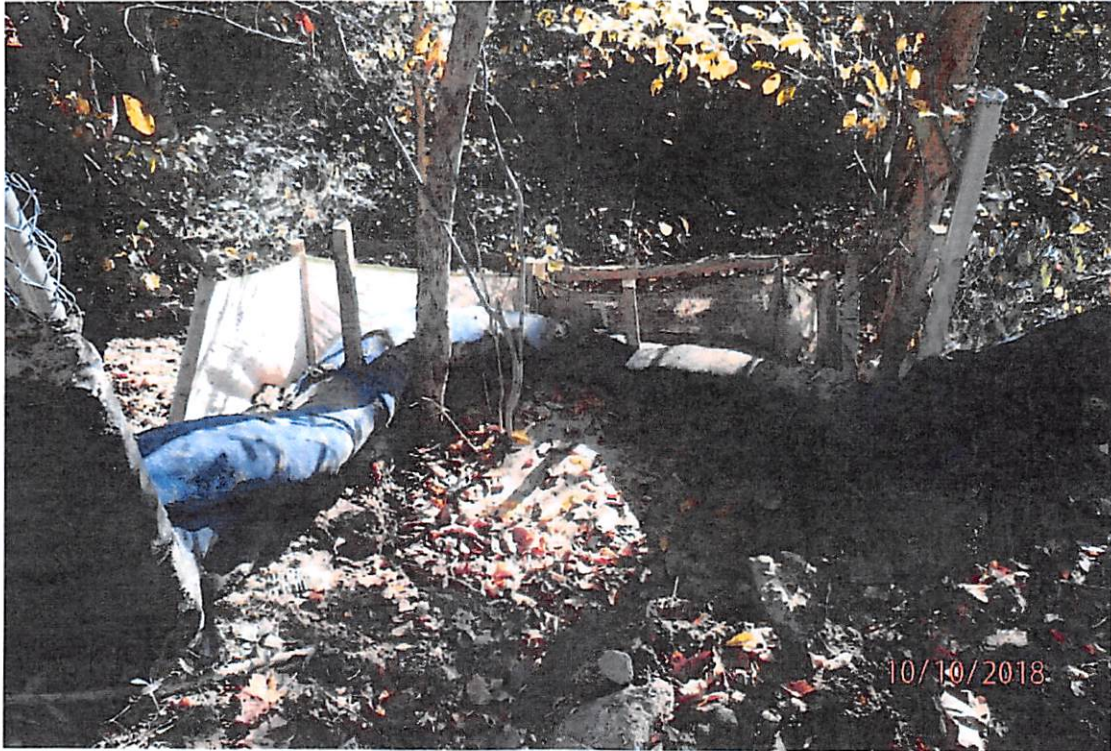
BMP adjacent to UNT Morgans Run that is in need of maintenance.

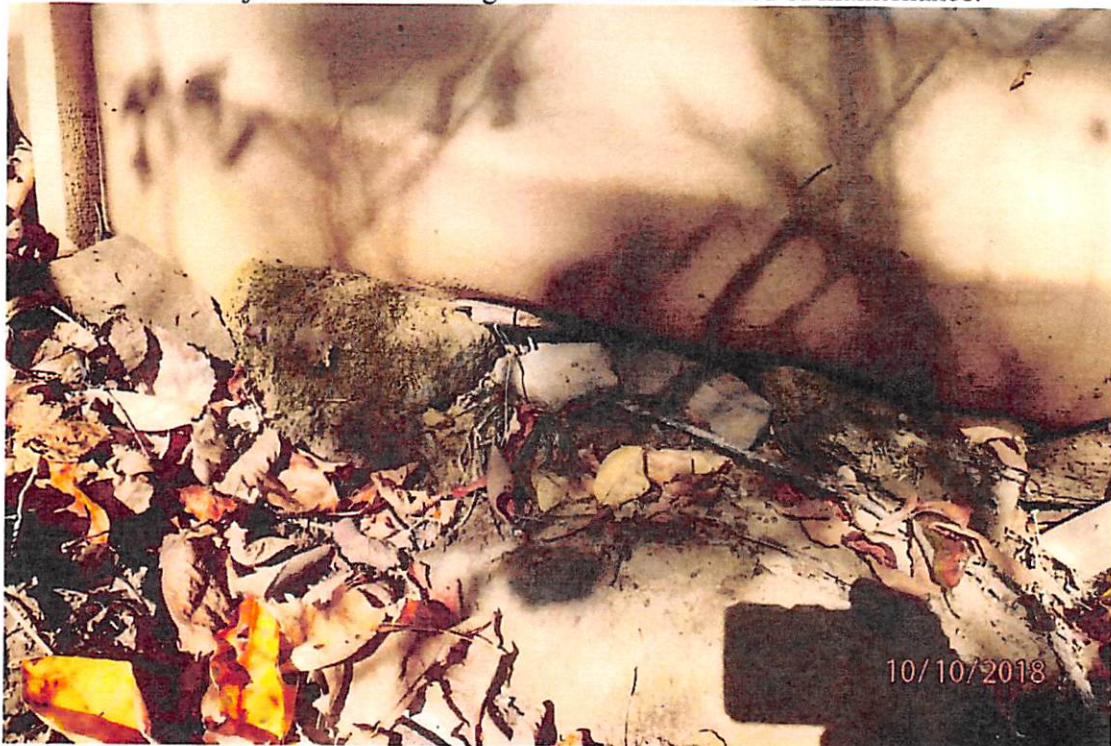
View of above pictured BMP from downslope showing rocks that are being utilized in an attempt to plug an area where sediment laden water is bypassing the BMP.

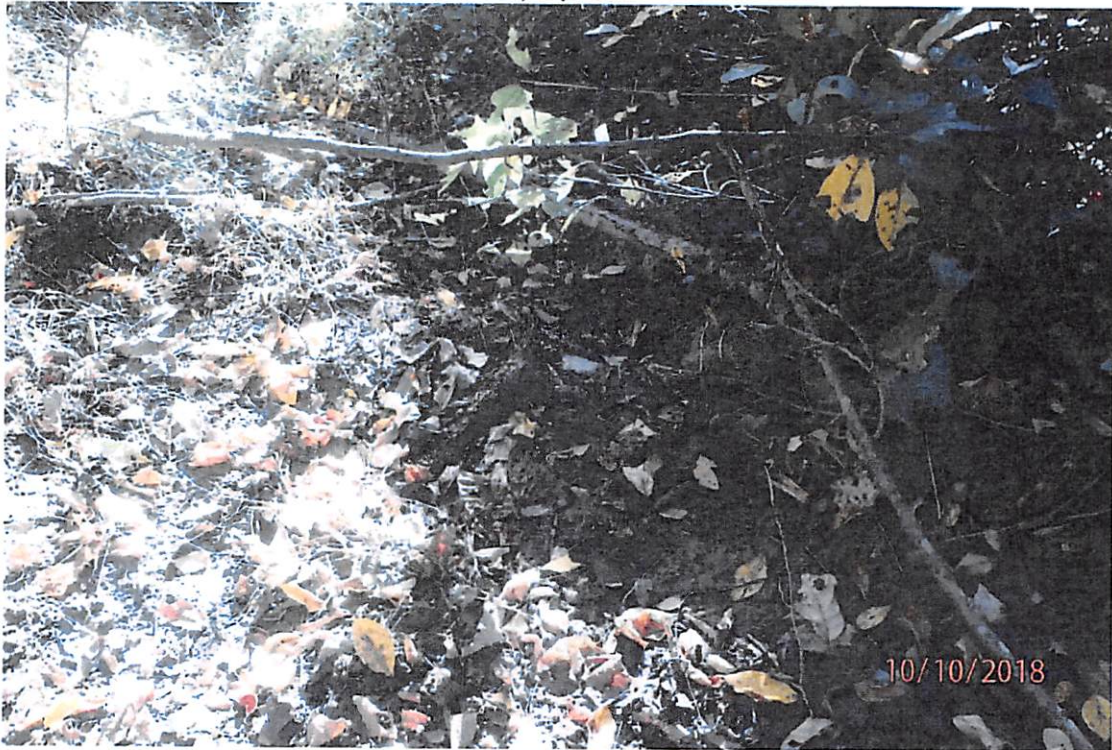
Offsite CNA deposits in UNT Morgans Run (39°17.640' X 80°40.738') as a result of the previously pictured BMP.

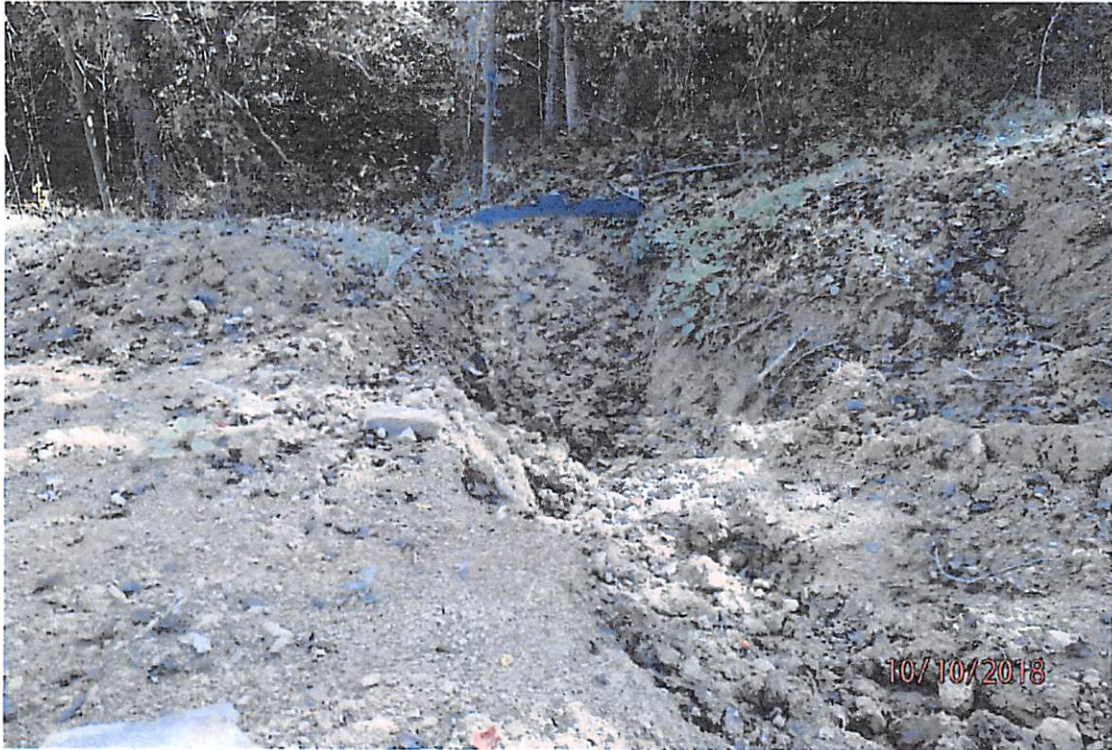
BMP in need of maintenance that resulted in CNA in UNT Righthand Fork of Morgans Run (UNT 2) (39°17.932' X 80°40.600').

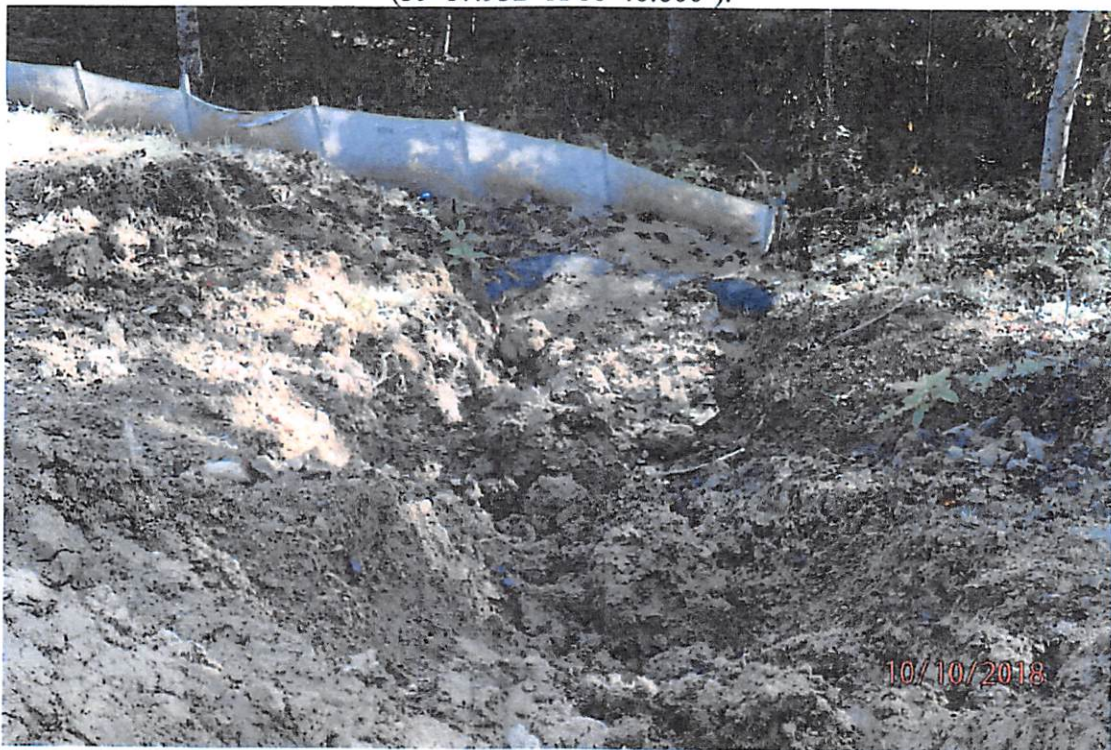
BMP in need of maintenance that resulted in CNA in UNT Righthand Fork of Morgans Run (UNT 2) (39°17.932' X 80°40.600').

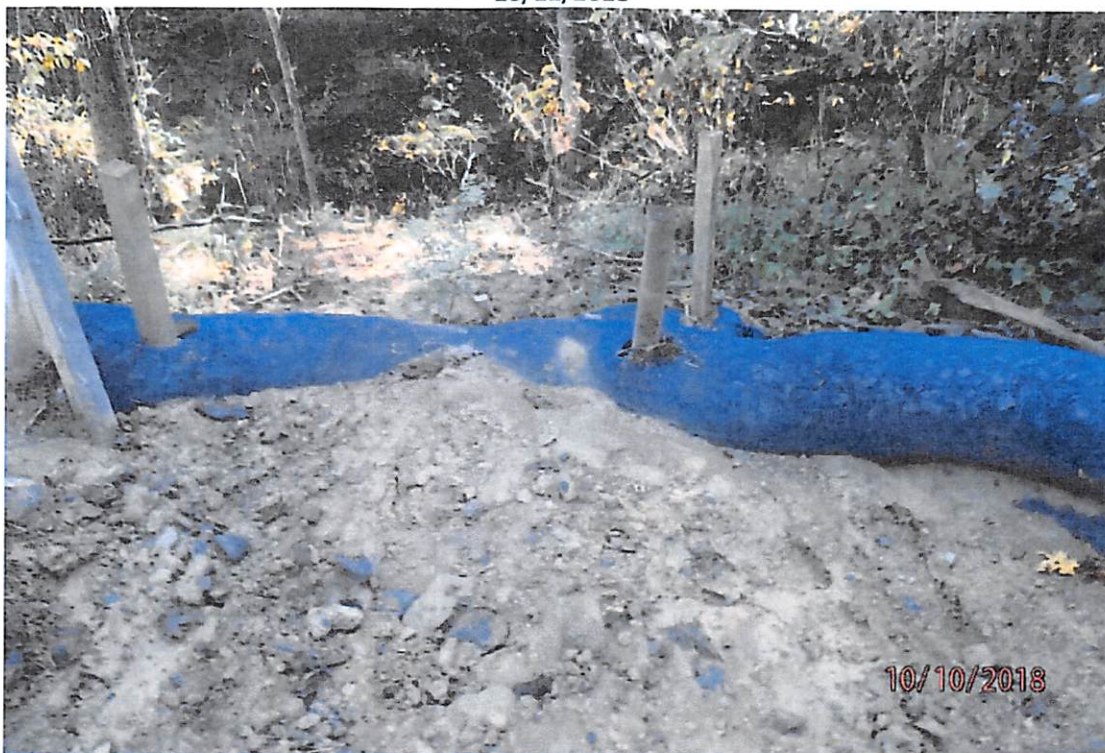
BMP in need of maintenance that resulted in CNA in UNT Righthand Fork of Morgans Run (UNT 2) (39°17.932' X 80°40.600').

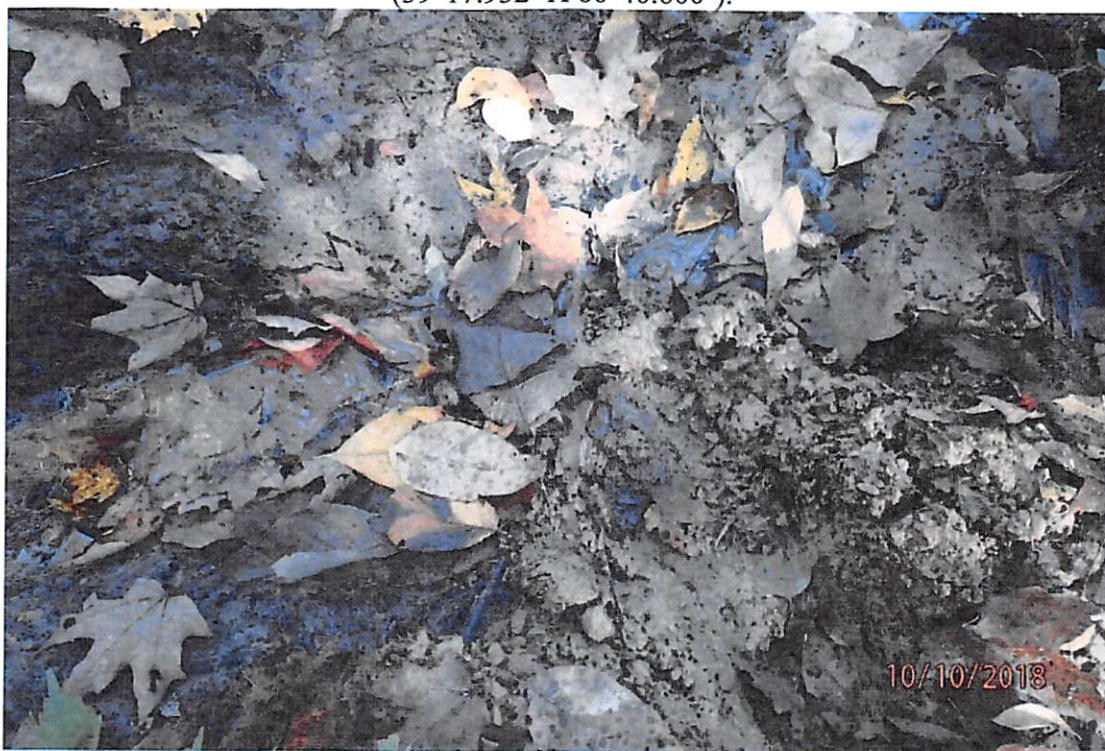
Offsite CNA deposits in UNT Righthand Fork of Morgans Run (UNT 2) (39°17.932' X 80°40.600').

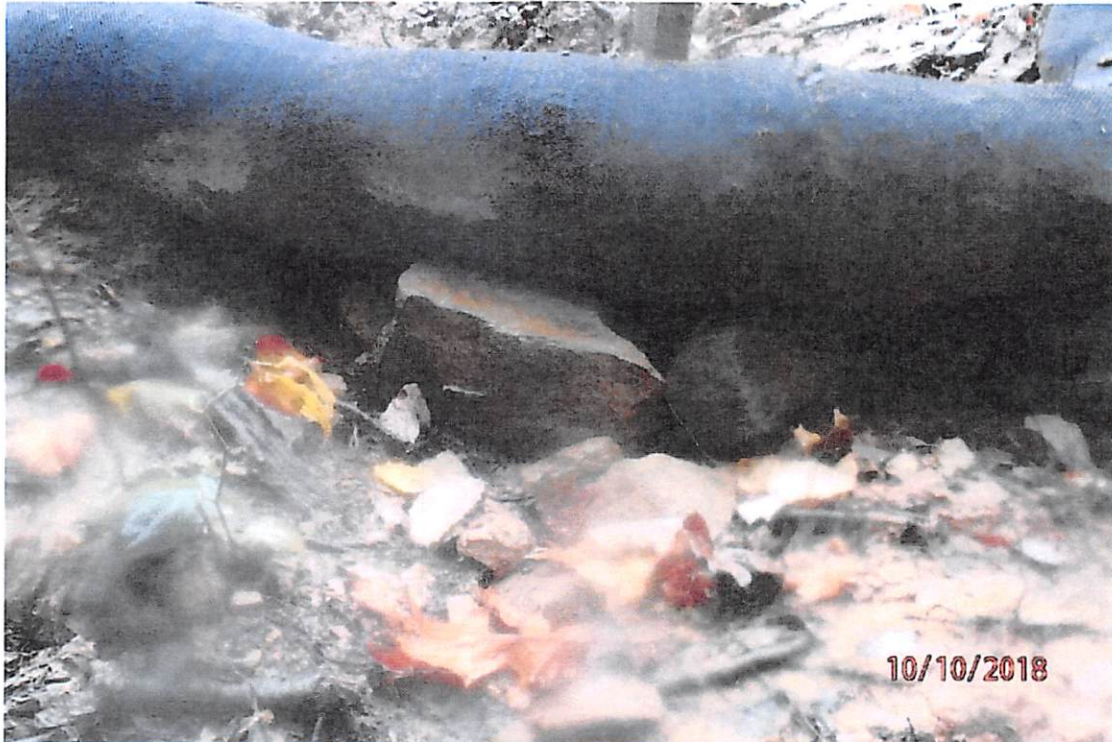
Downslope view of above pictured BMP showing rocks that have been placed in an area where sediment laden water is bypassing the BMP in an attempt to plug the area of bypass.

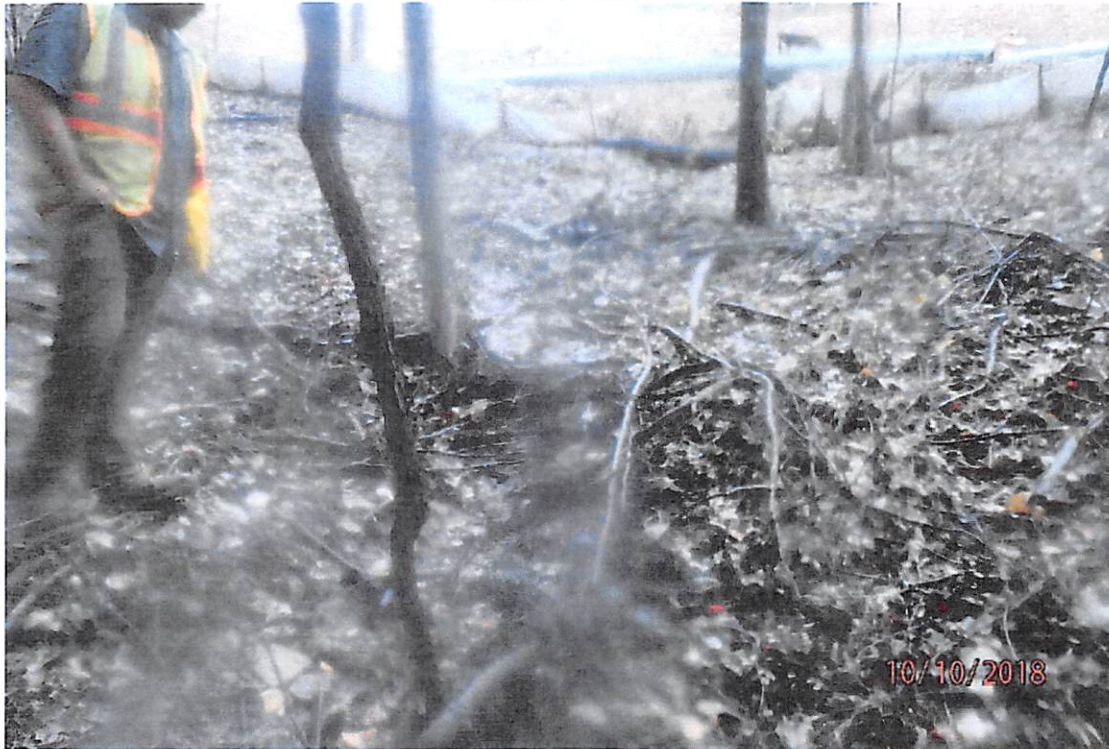
UNT Flint Run downslope of the BMP in need of maintenance.

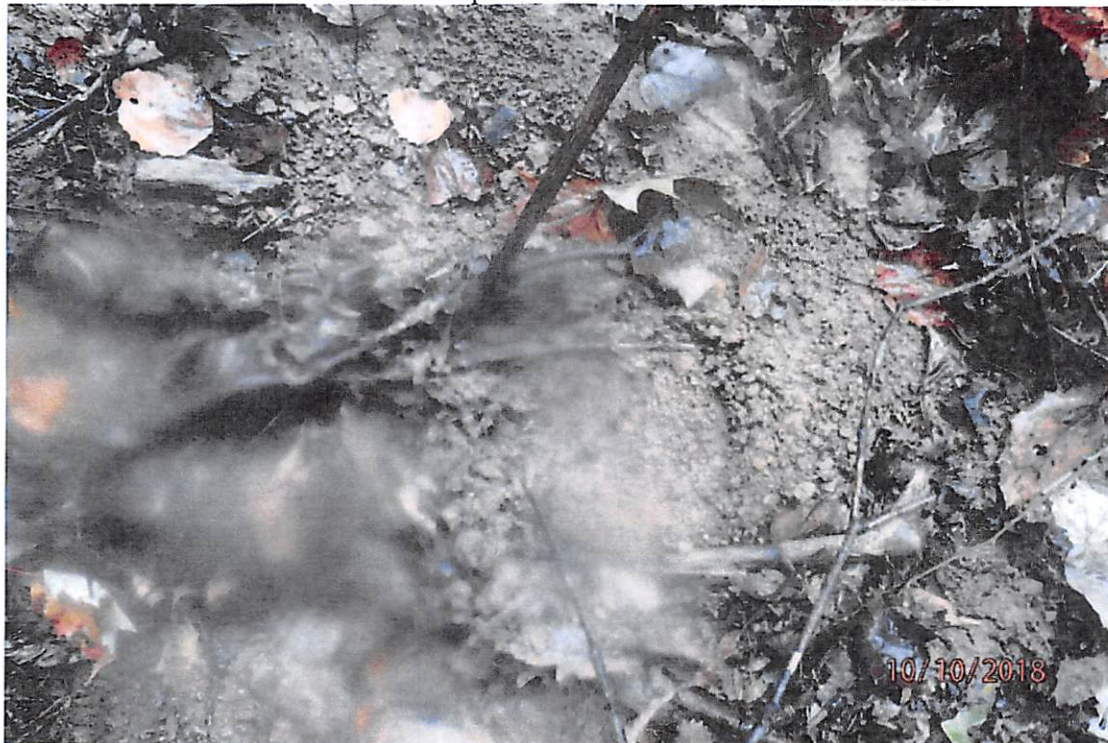
Offsite CNA deposits in UNT Flint Run (39°21.223' X 80°39.649') as a result of the previously pictured BMP.

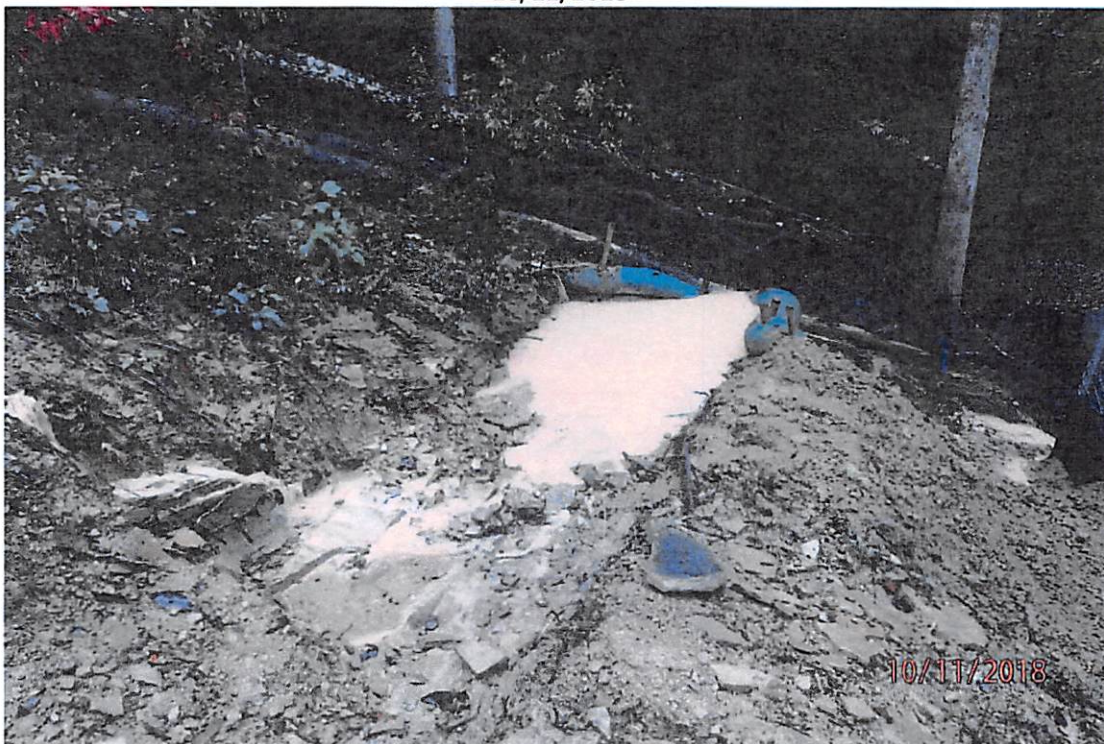
Sediment laden water bypassing an unmaintained and poorly operated water bar terminus BMP adjacent to UNT Franks Run (39°25.922' X 80°37.079').

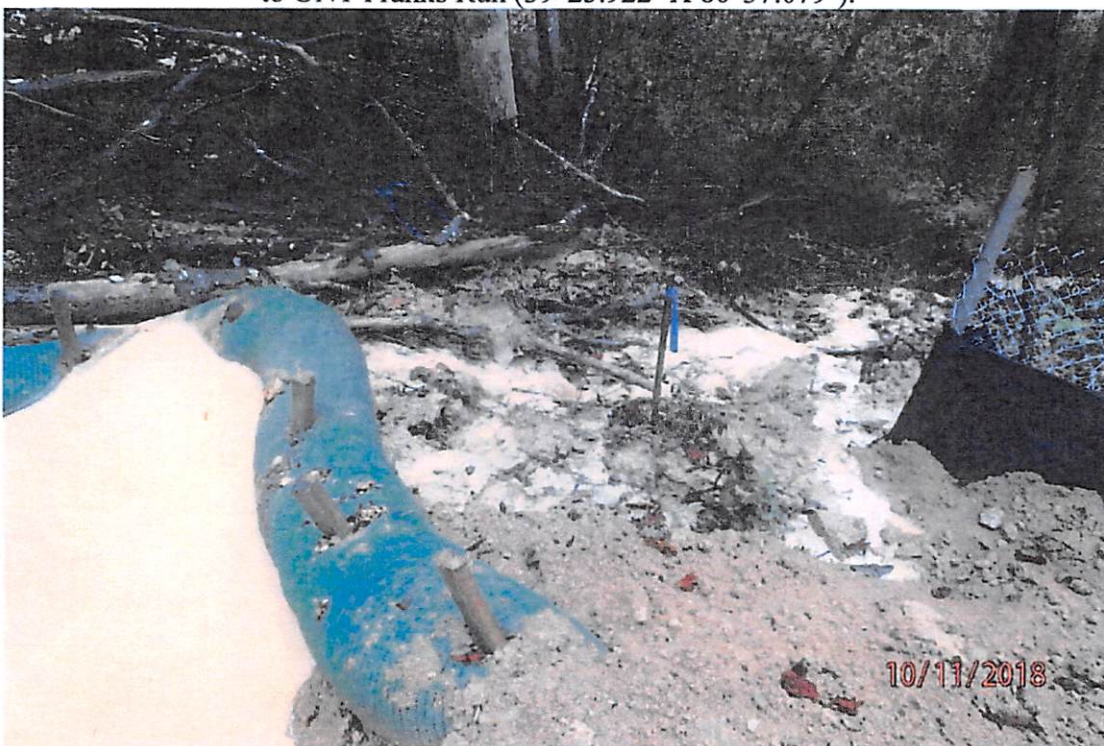
Sediment laden water bypassing an unmaintained and poorly operated water bar terminus BMP adjacent to UNT Franks Run (39°25.922' X 80°37.079').
